Vehicle Technical Inspection Form

NISSAN Pathfinder

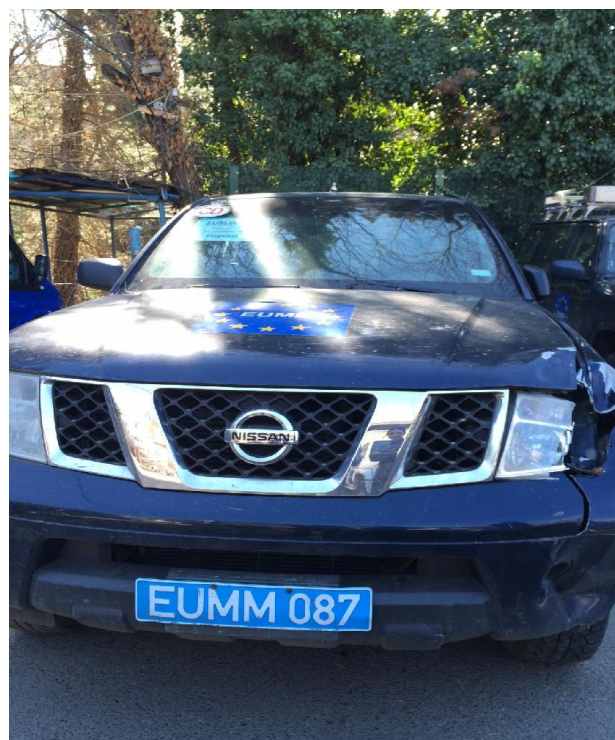
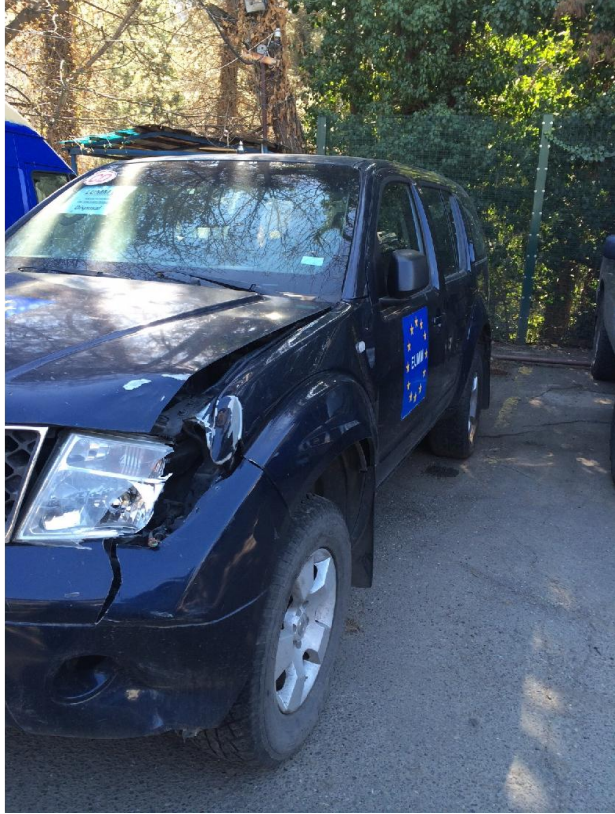
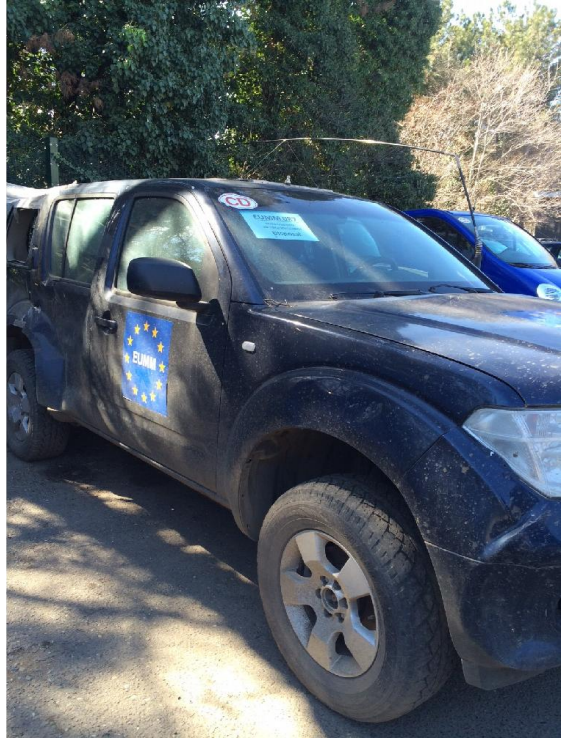
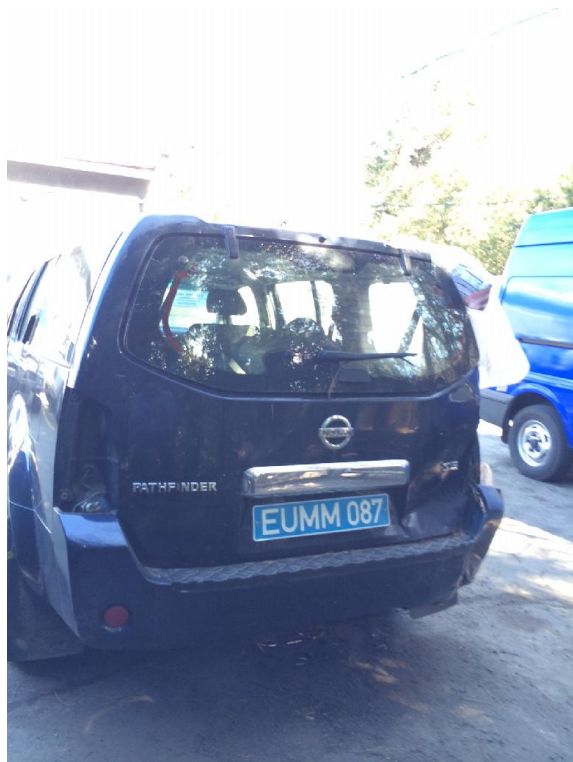
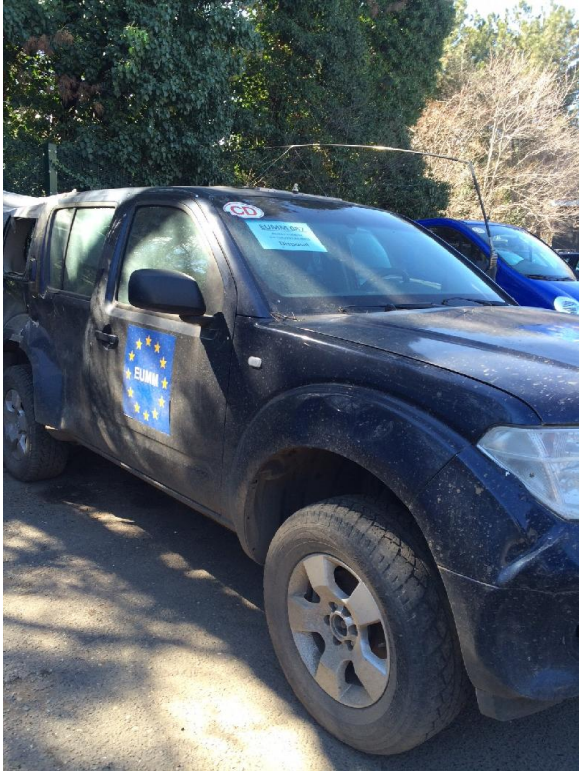
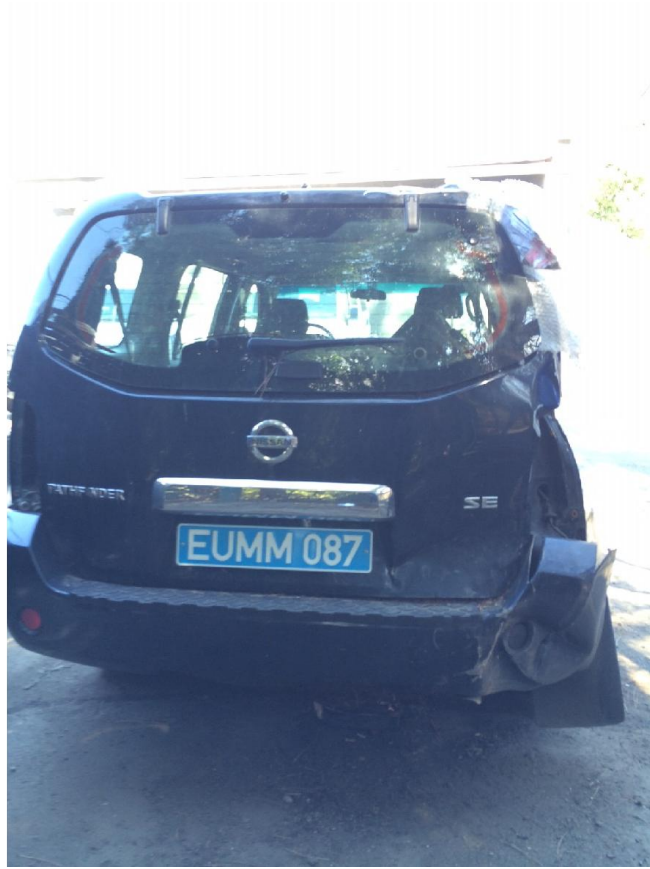
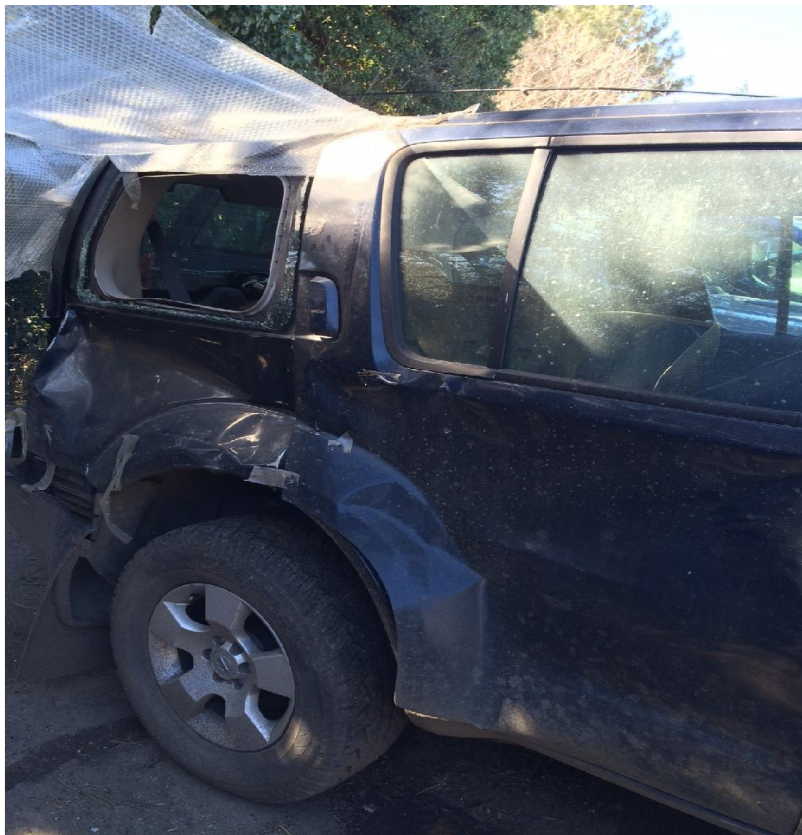
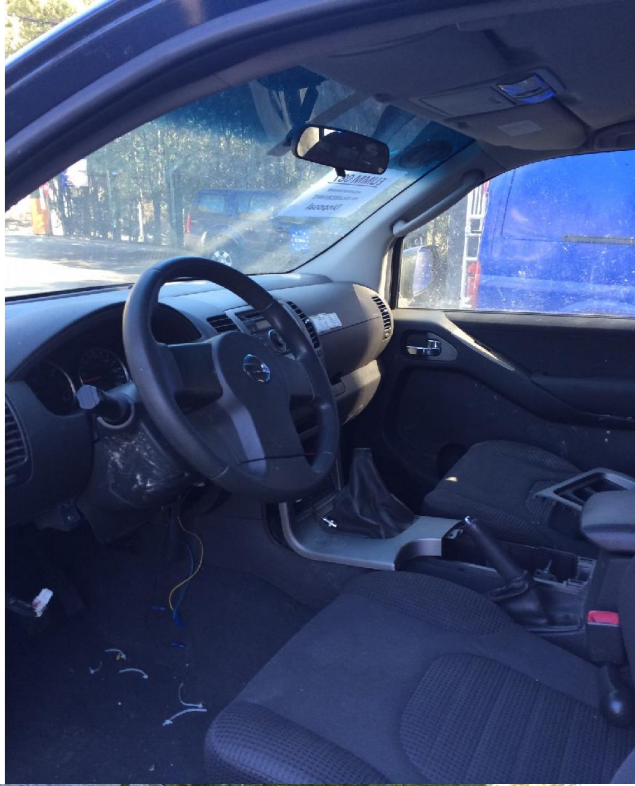
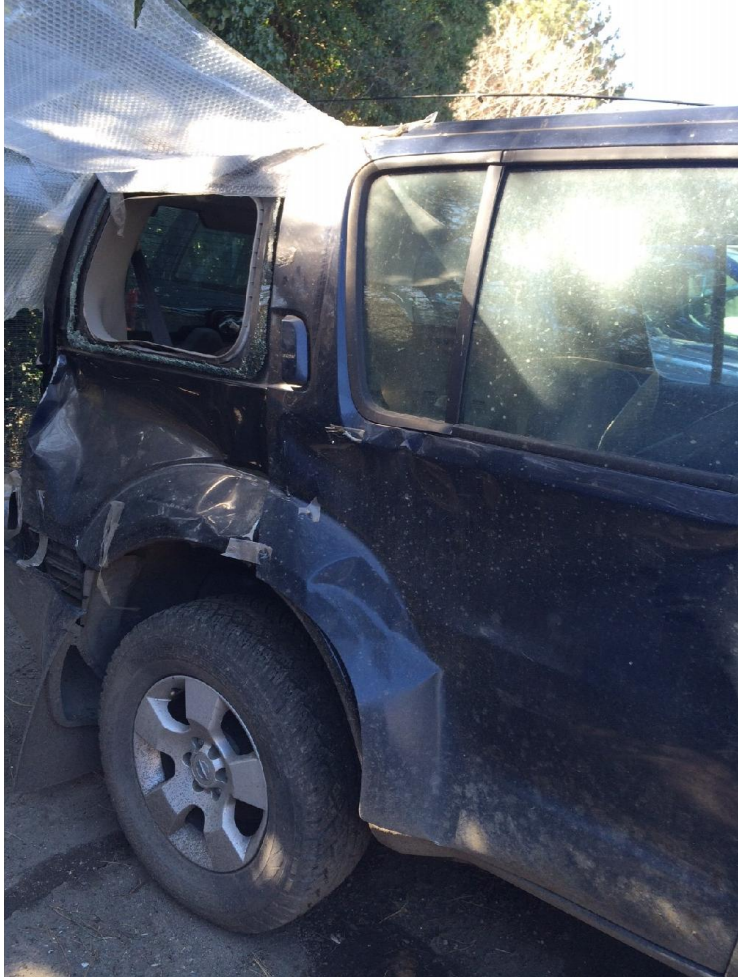
- The vehicle is damaged (rolled over in a ravine). Front bumper, bonnet, front LH light, grill bar, doors, rear bumper and rear lights are damaged. Trunk RH side window broken
- Interior dirty

Gear Box removed (Oil leaking from differential transfer box)
Fuel level Sensor and Fuel Pump removed (damaged)
Pan assy oil removed (damaged)
FM Radion damaged
Door inner handle broken
Steering column needs to be be replace

Require thorough repairs
